TECHNICAL REPORT GL-81-2

15 MILE ROAD/EDISON CORRIDOR SEWER TUNNEL FAILURE STUDY DETROIT AREA, MICHIGAN

Geotechnical Laboratory
U. S. Army Engineer Waterways Experiment Station
P. O. Box 631, Vicksburg, Miss. 39180

January 1981

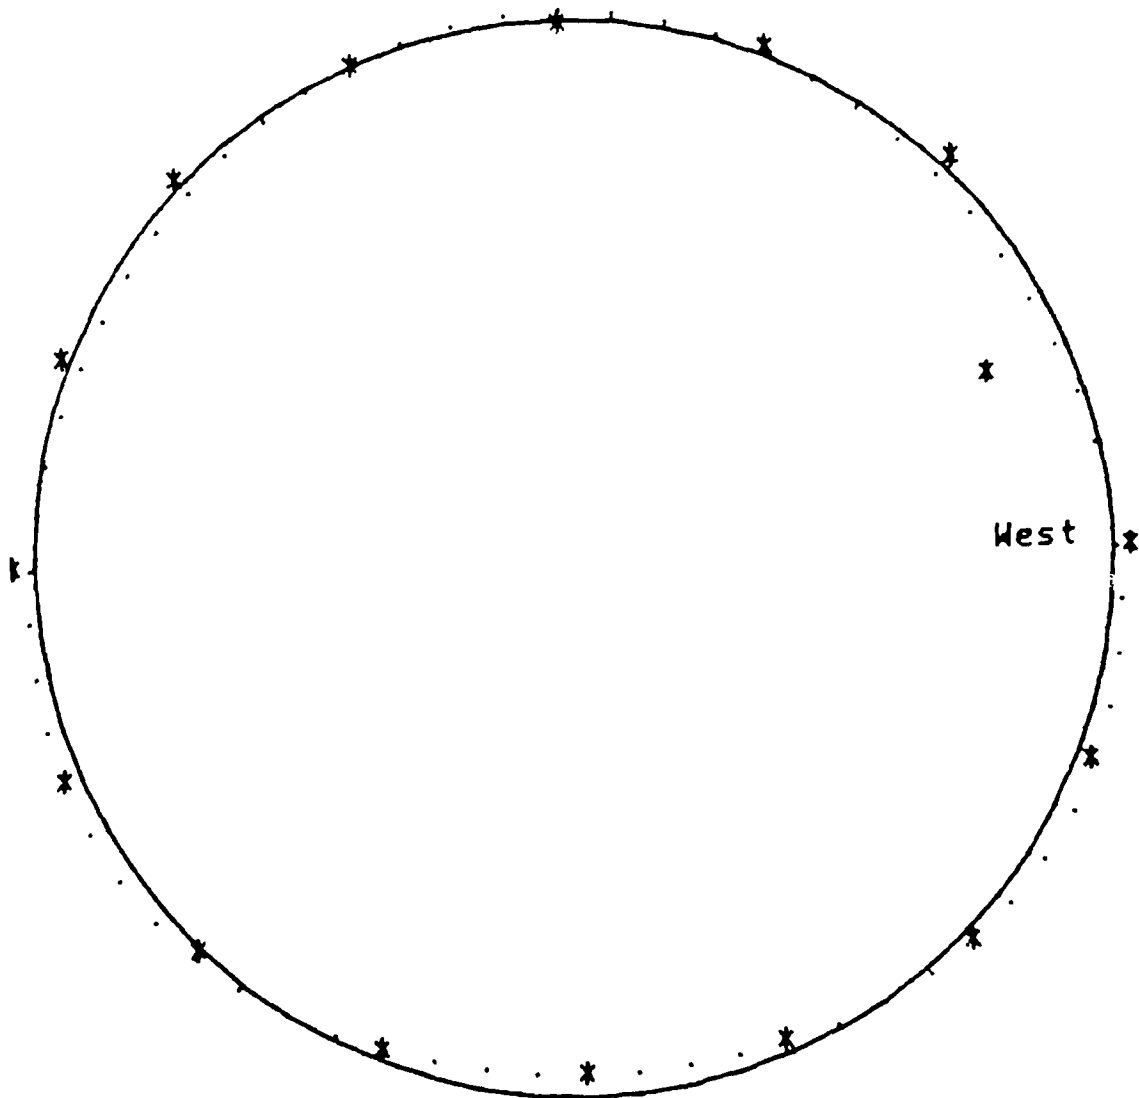
PCI-7 STA 112+50

$w/r = 0.0143$ s.

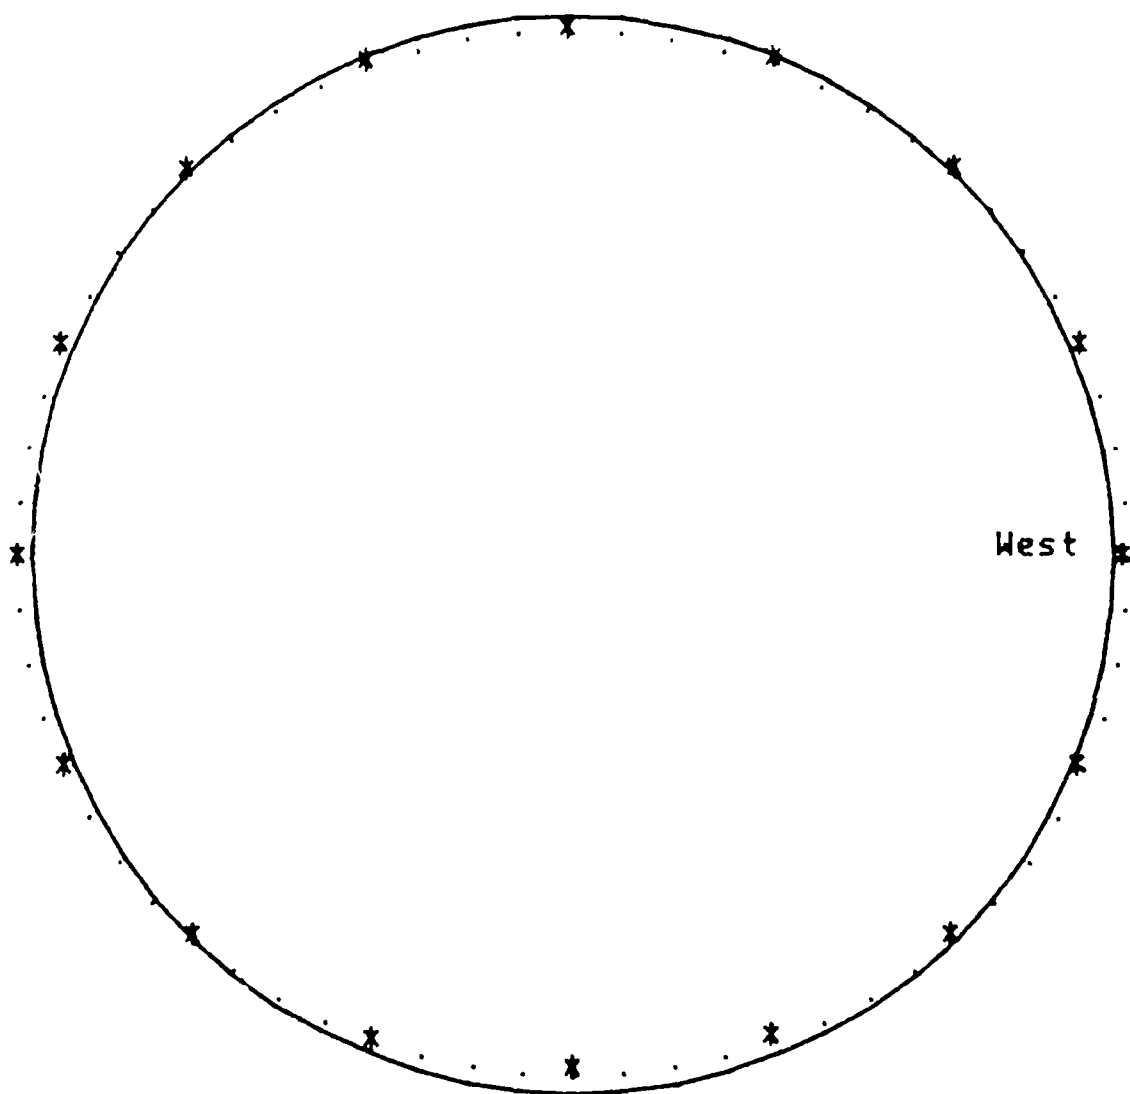
PCI-7 STA 112+25

$w/r = 0.0297$

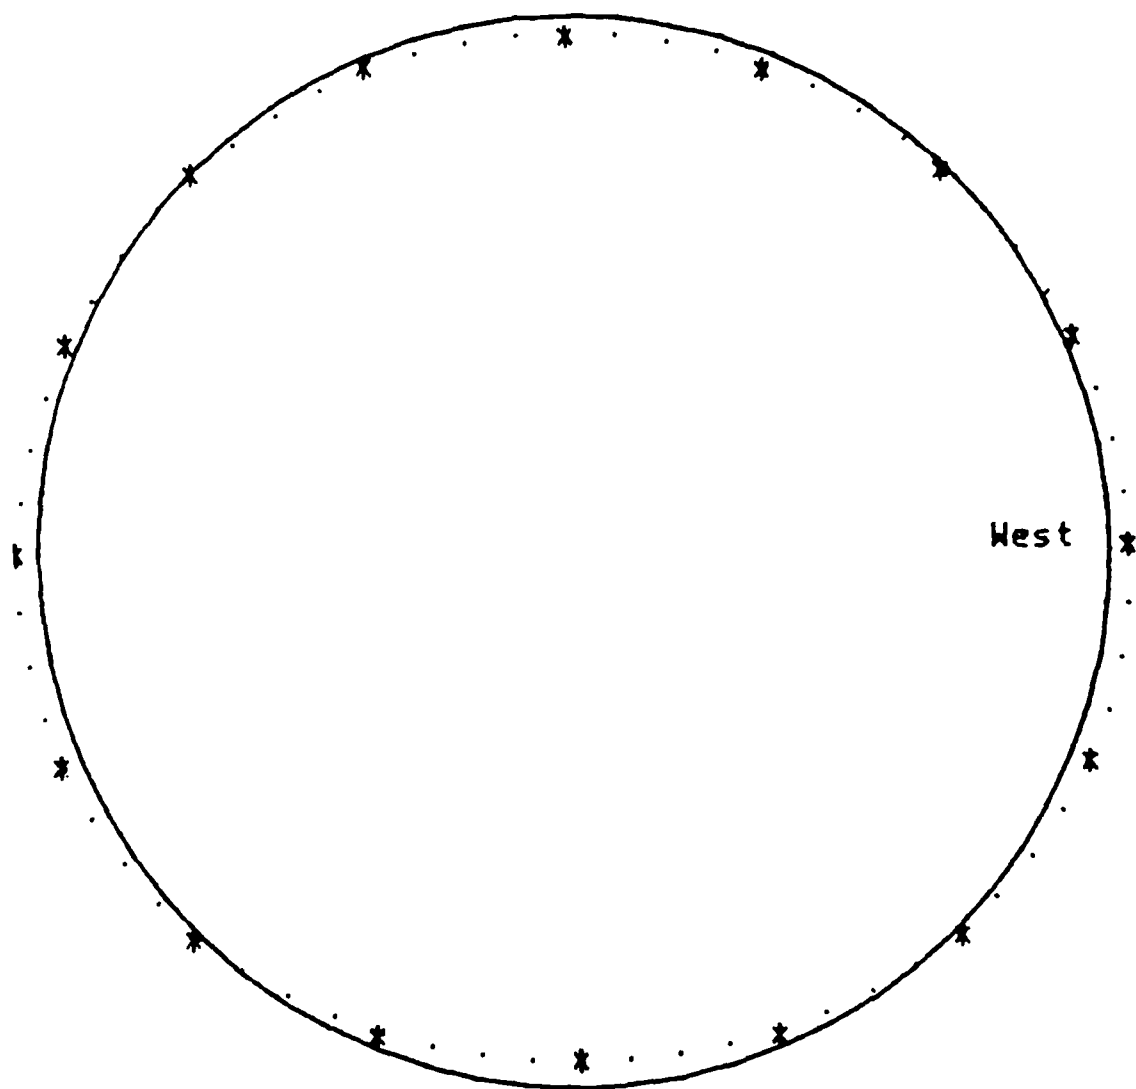
PCI-7 STA 112+00

w/r= 0.0400

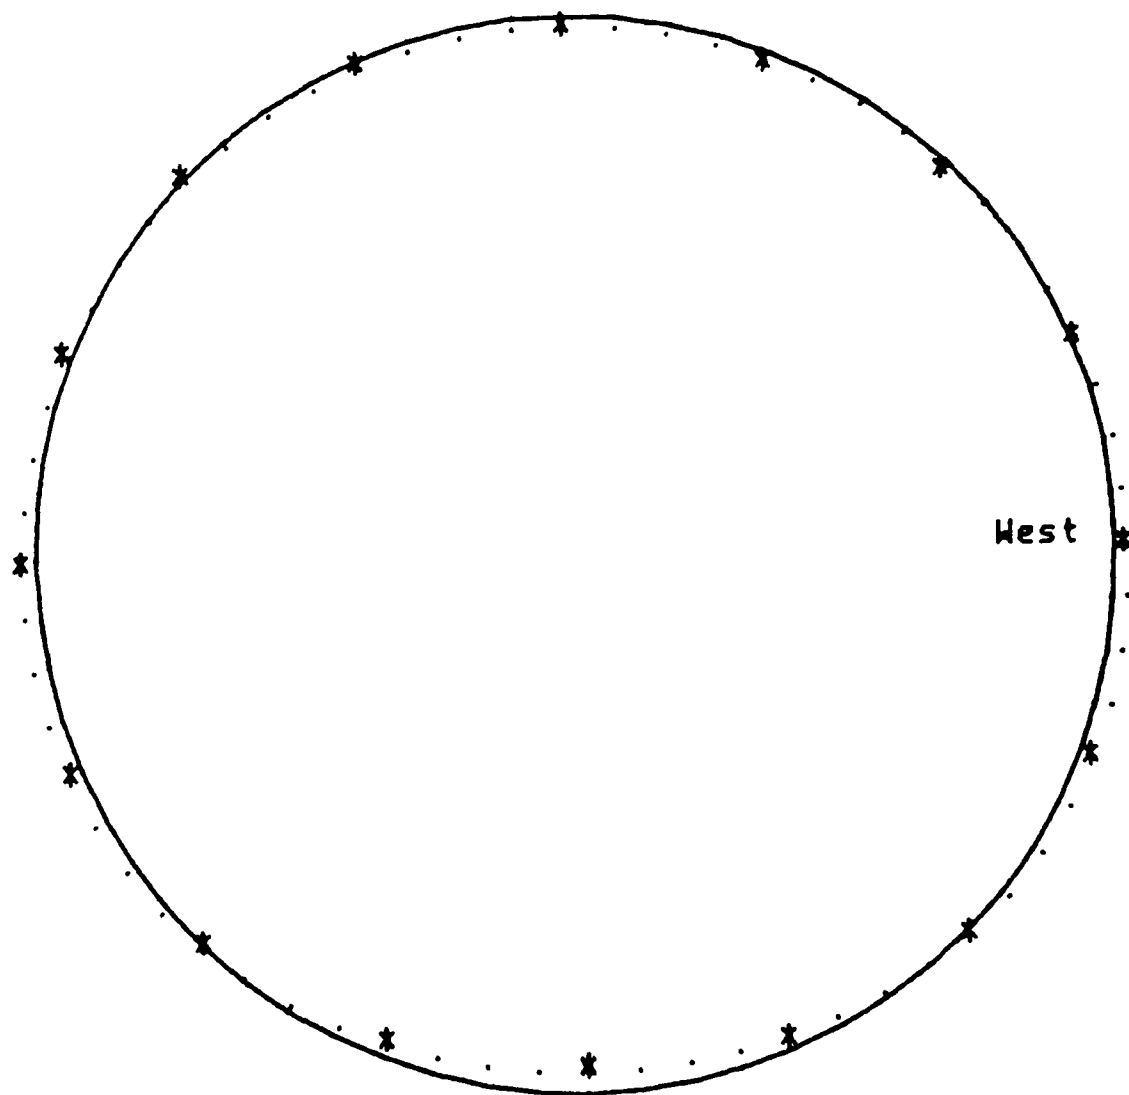
PCI-7 STA 111+75

w/r= 0.0287...

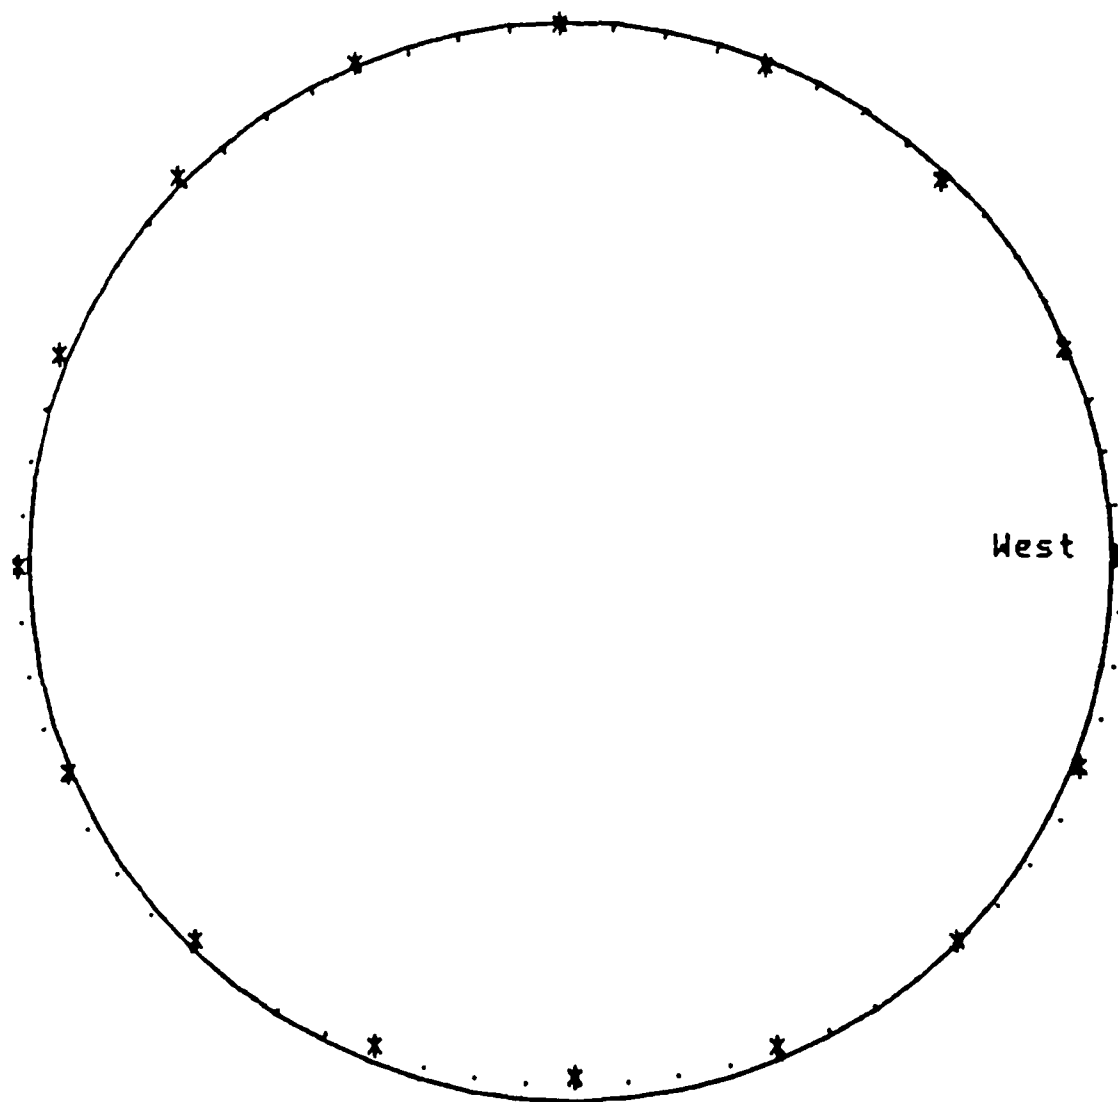
PCI-7 STA 111+50

w/r= 0.0203.

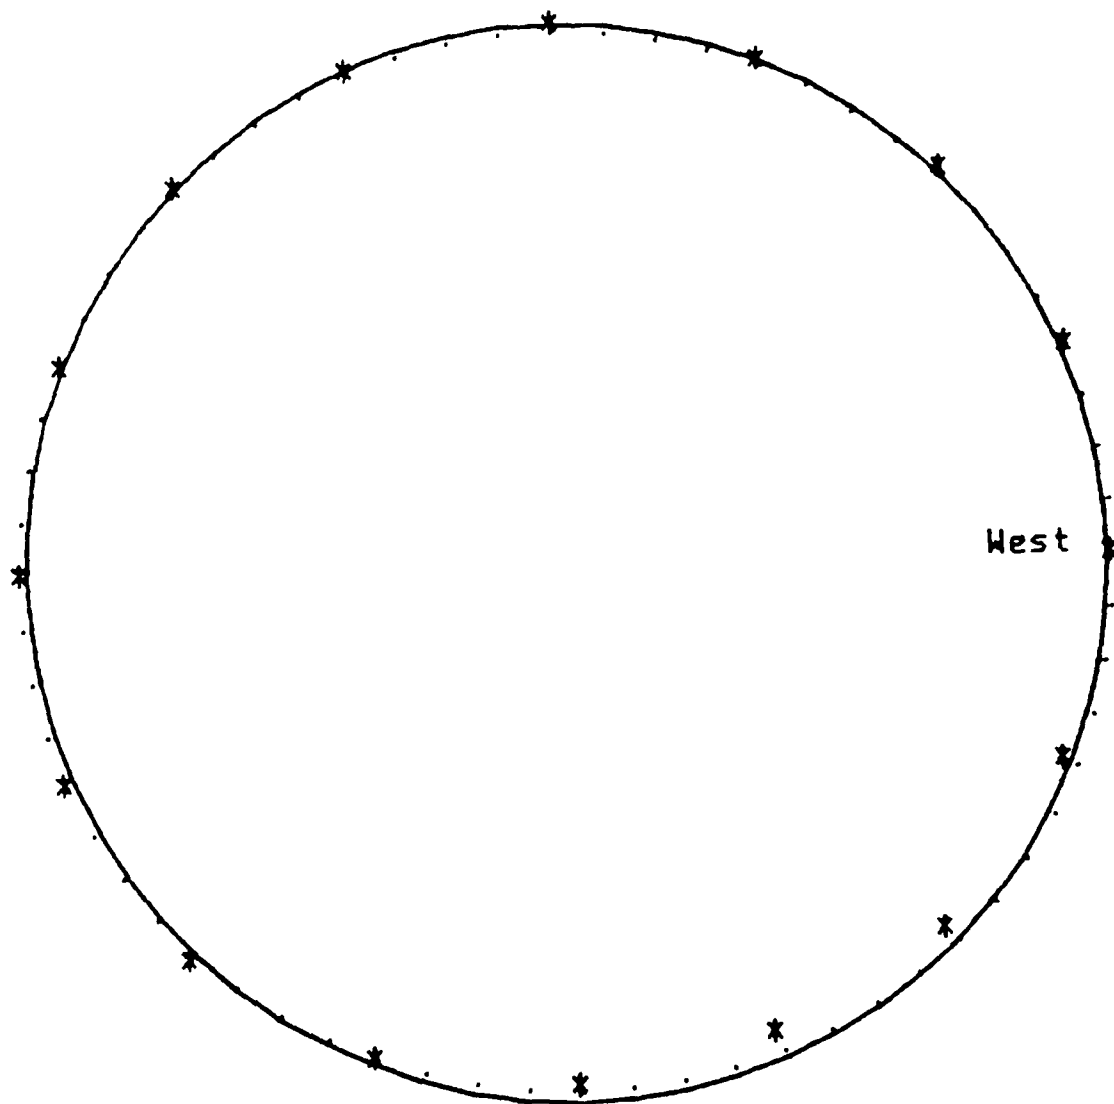
PCI-7 STA 111+25

$w/r = 0.0157$

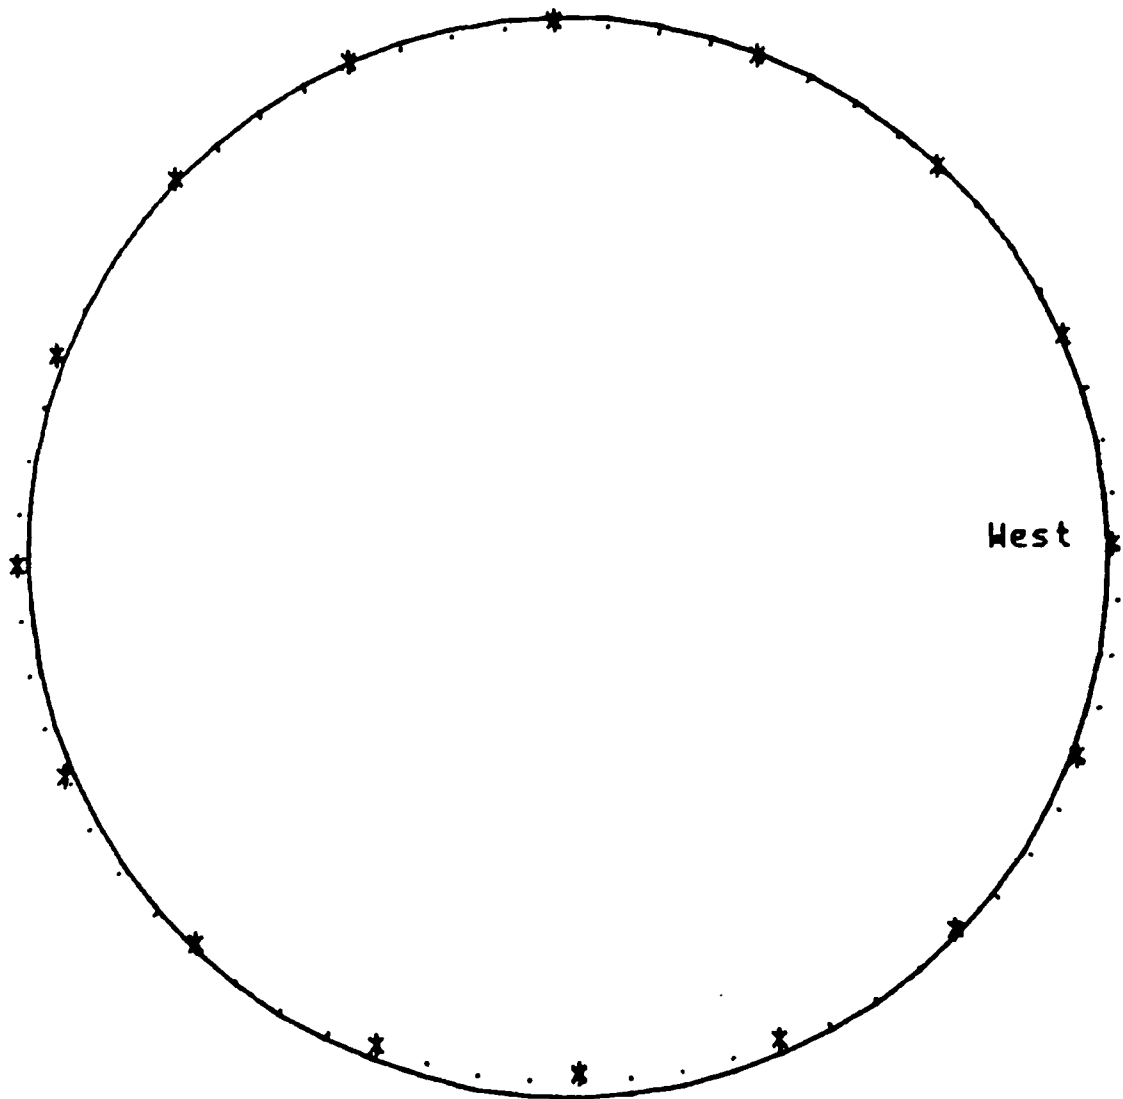
PCI-7 STA 111+00

w/r= 0.0217

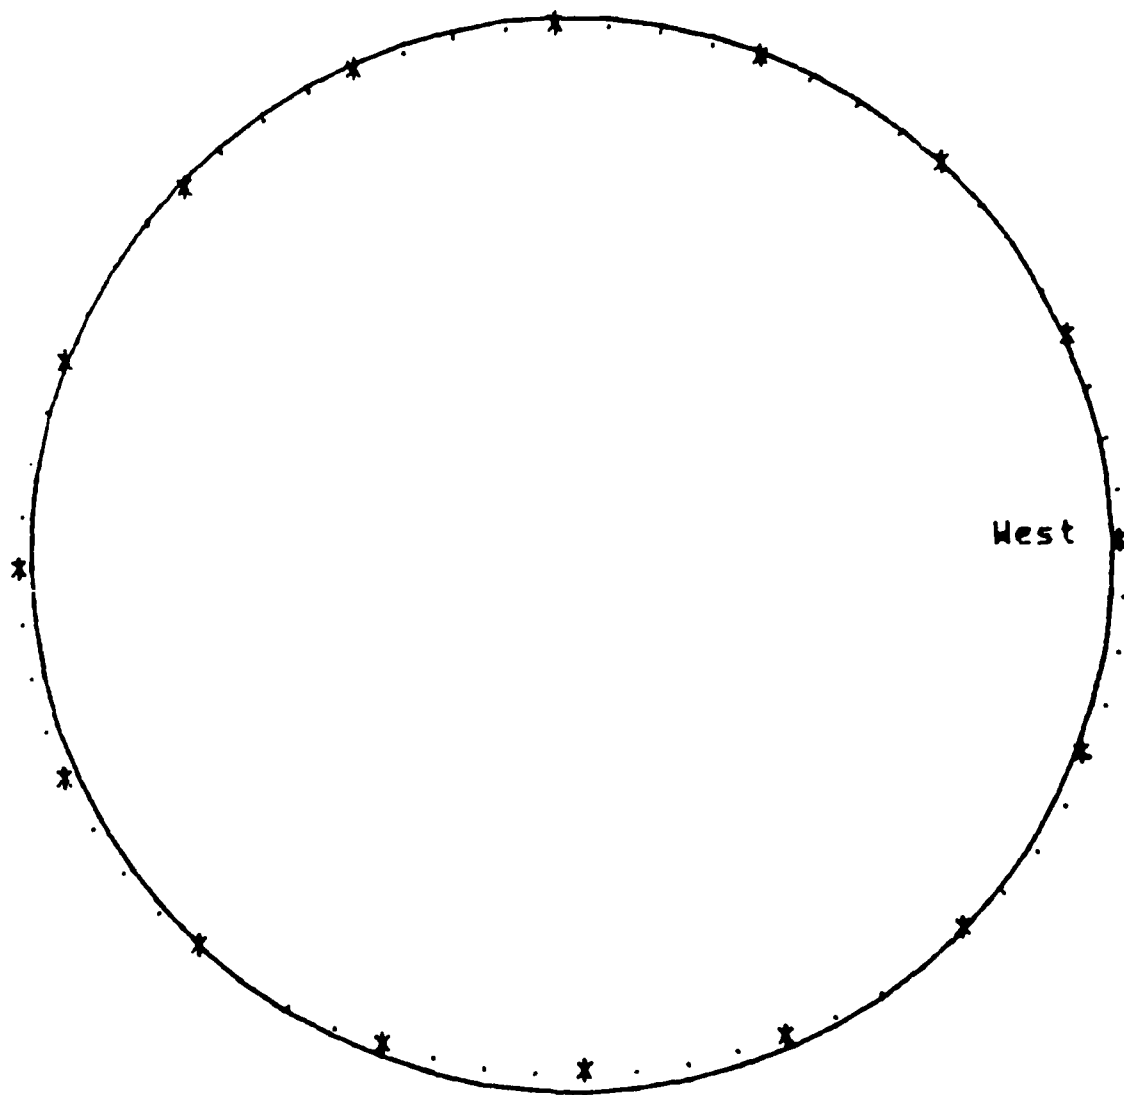
PCI-7 STA 110+75

$w/r = 0.0237$
